## SPECIAL AIRWORTHINESS INFORMATION BULLETIN

NO. ACE-97-04  
MAY 29, 1997

## **L’Hotellier Ball and Swivel Joint Quick Connectors**

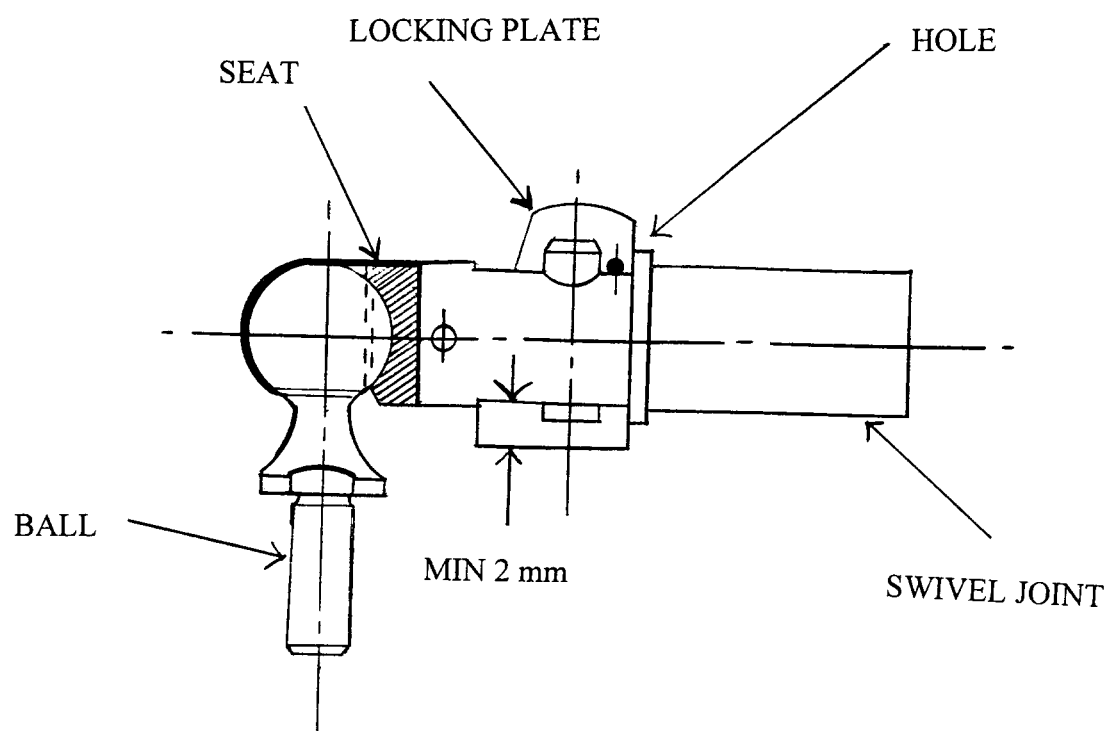
**FIGURE 1**

For ball and swivel joint quick connectors with lock plates:

If these connectors have a safety pin guide hole, the hole may be enlarged to a maximum of 1.2mm (0.05 in) to accommodate an appropriate aviation locking device (i.e., safety wire, pin, etc.) If the locking device already fits the guide hole, then this hole enlargement is not necessary (reference Figure 1). Because of the various locations, accessibility to the fittings, etc., the appropriate type of aviation locking device is at the discretion of the certified mechanic. However, the FAA recommends that the owner/operators use the locking devices that are supplied by their respective glider/sailplane manufacturer.

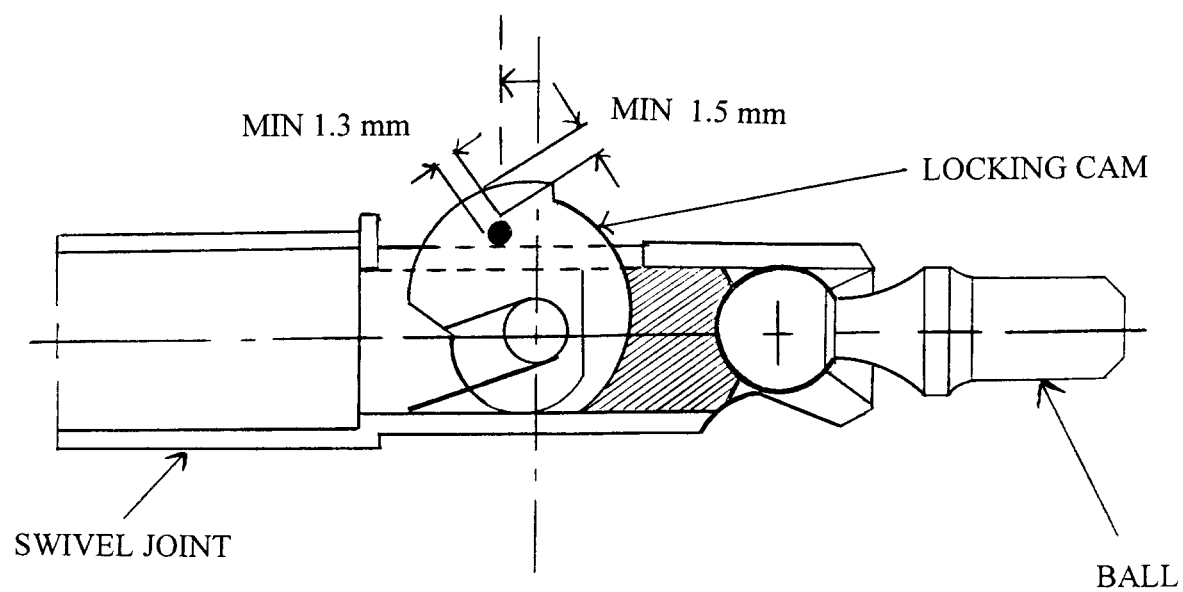
**FIGURE 2**

For ball and swivel joints quick connectors with locking cams:

If the locking cam does not have a safety pin guide hole, the hole may be drilled to a maximum diameter of 1.3mm with the ball correctly inserted so that one edge of the hole would be level with the main body of the joint and at least 1.5mm of material is left on the other side. When the ball is seated correctly, the hole is located aft of the centerline of the cam pivot point (as noted by the dashed line on Figure 2). It is important to have the ball

seated correctly in the joint when the hole is marked and the ball and swivel connected when the hole is drilled (reference Figure 2). Suitable locking devices have been identified by the manufacturers with respect to their specific type design features. Contact the U.S. sailplane company representative or manufacturer for any technical information.
